NASA TN D-1866

DESCRIPTION AND PERFORMANCE OF THREE TRAILBLAZER II REENTRY RESEARCH VEHICLES

*by Reginald R. Lundstrom, Allen B. Henning,
and W. Ray Hook*

*Langley Research Center
Langley Station, Hampton, Va.*

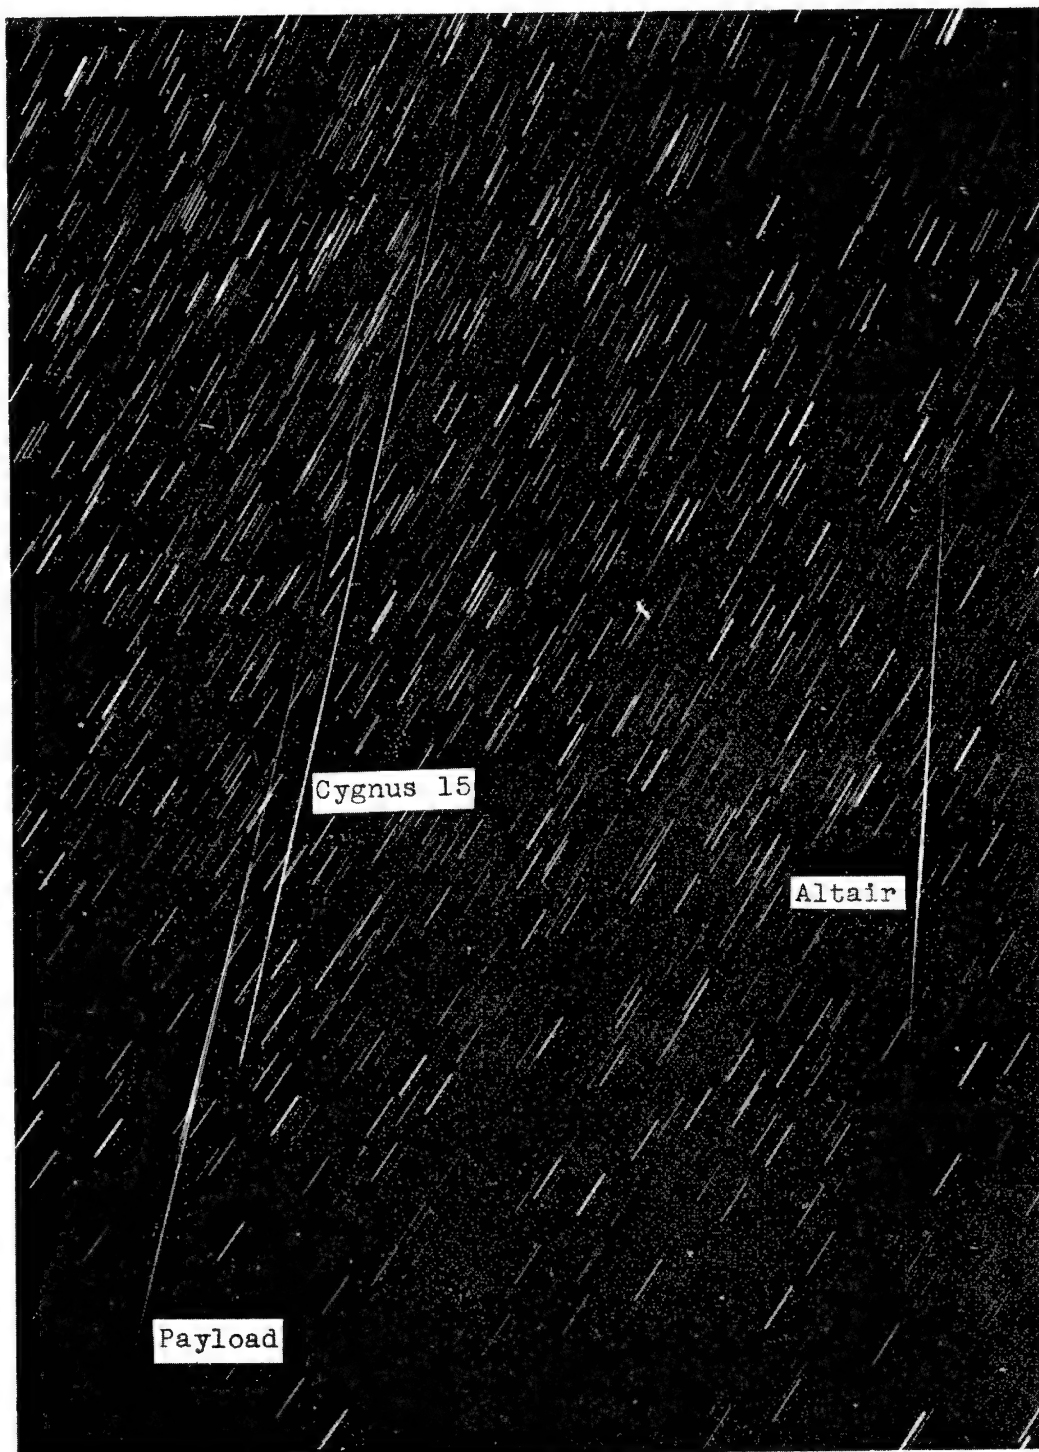
Figure 22.- Photographs of the reentry taken from Coquina Beach, N.C. .

Presented herein are some optical and radar data obtained during the reentry of the payloads into the atmosphere. The analysis of these data is beyond the scope of this report, but figures 22 and 23 are presented to show the type of data obtained and to indicate that the specific flight was successful from the standpoint of obtaining reentry data. Photographs taken from Coquina Beach, North Carolina, of the reentry streaks from the three vehicles presented herein are shown in figure 22. These photographs show not only the payload reentry streak but also the reentry streaks of the burned-out rocket motors and occasionally other debris released from the reentry system. In each case the photograph includes all the reentry objects that were present for each shot. Some cameras were equipped with a rotating shutter which cut off the light entering the camera for short precisely measured intervals. This gave an interrupted or chopped trace on the streak photograph from which velocity calculations could be made. The traces on the photographs presented in figure 22 are unchopped, but other photographs not shown here were time chopped so that velocity calculations of the reentry object could be made. In figure 22(b), the track of the pellet is at an angle to the track of the fifth-stage rocket motor, which, as mentioned previously, indicates that a large wobble angle was present. The velocity data for the pellet were obtained from chopped photographs. It was not possible to check this velocity with radar data since the radars cannot track an object as small as the pellet. Other payloads were tracked by radar and their photographic and radar velocity data can be compared. The variation of radar cross section
